## **LOUISA BOREN RESTORATION PLAN**

### **Abstract**

The project restoration site is located in Louisa Boren Park just south of Interlaken Boulevard on Capitol Hill. It comprises a ravine basin and the surrounding slopes, characterized by wetland and upland habitats. Currently, invasive plant species are widespread at the site and are compromising the integrity of the native vegetation community. Site assessments provided information on soils, hydrology, climate, and existing vegetation that allowed for informed decisions regarding site preparation, plant selection, and installation. The main goal of our project is to develop a strategy to re-instate a self-sustaining upland and wetland ecosystem that will harmonize with site usage. The plan includes recommendations on removing invasive plants, controlling erosion, removing hazard trees, installing and establishing appropriate native vegetation, and devising proper management and monitoring strategies to ensure the best chances for restoration success.

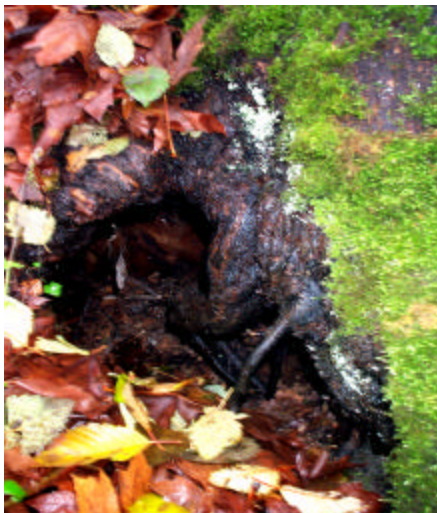
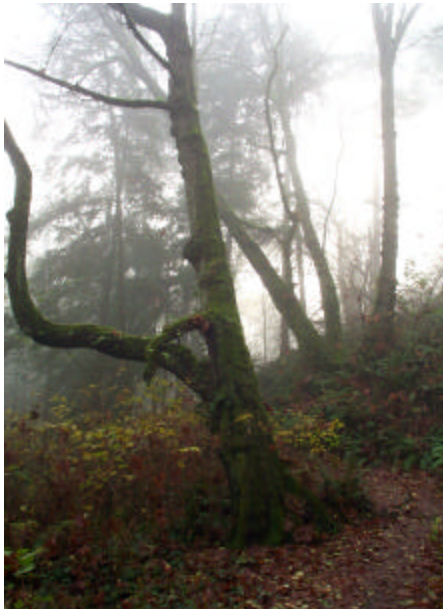
### Tree #1:

Comments: There is a large cavity at the base of the tree with approximately 4-6 inches of holding wood for the entire circumference. No presence of fruiting bodies was detected, though rot is evident. The tree has a westerly lean of 20-30° toward the wetland.

Hazard trees identified in Section II: Site Assessment should be removed by a qualified arborist.

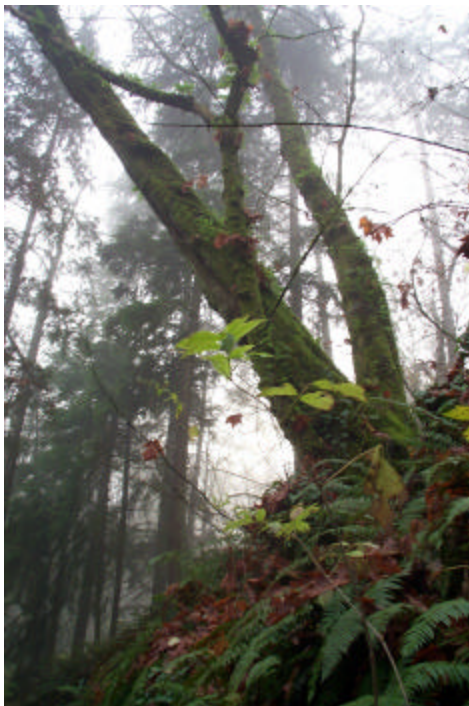
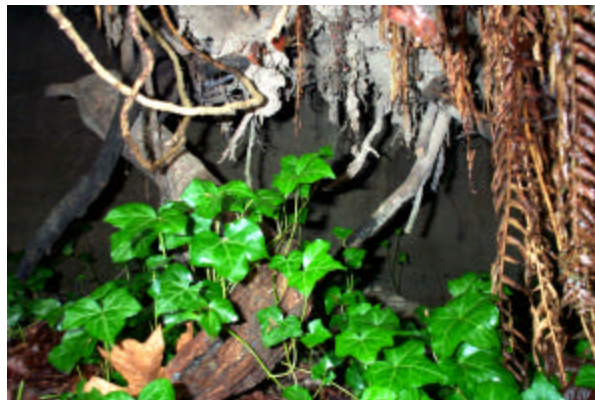
### Tree #2

Comments: Due to the under mining that is caused by the heavy runoff, half of the root ball has been exposed, weakening both the structure and health of the tree. The leader that is entirely dead hangs over the trail posing a threat to pedestrians; furthermore, the larger of the two living leaders is leaning at roughly 30-35° over the trail imposing more weight on the unstable root ball.

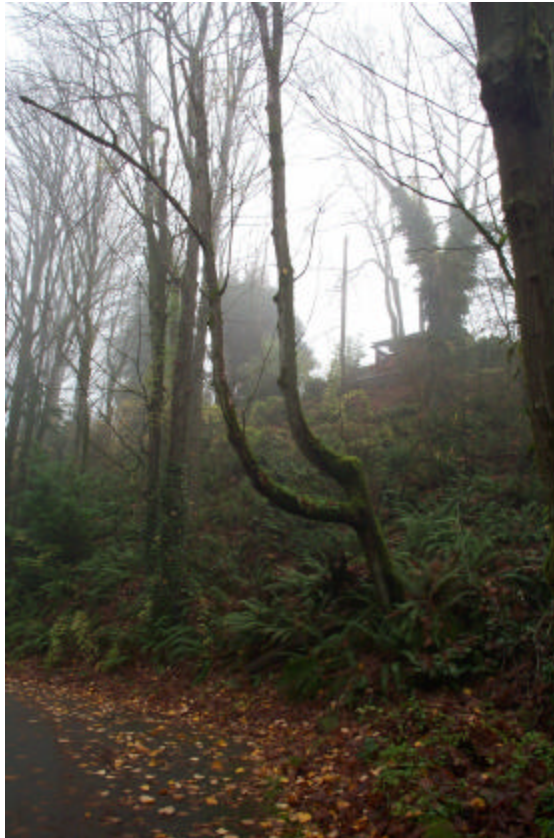
### **Tree #3:**

Comments: The tree has a 25° lean over the road with numerous pieces of deadwood that can easily fall on the road below creating hazards for motorists and pedestrians. It is my recommendation that this tree be removed immediately.

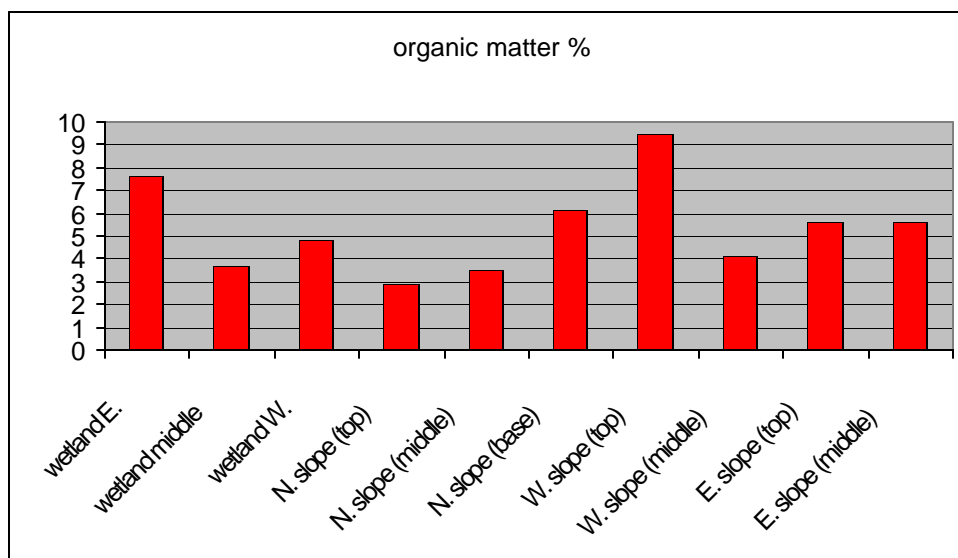
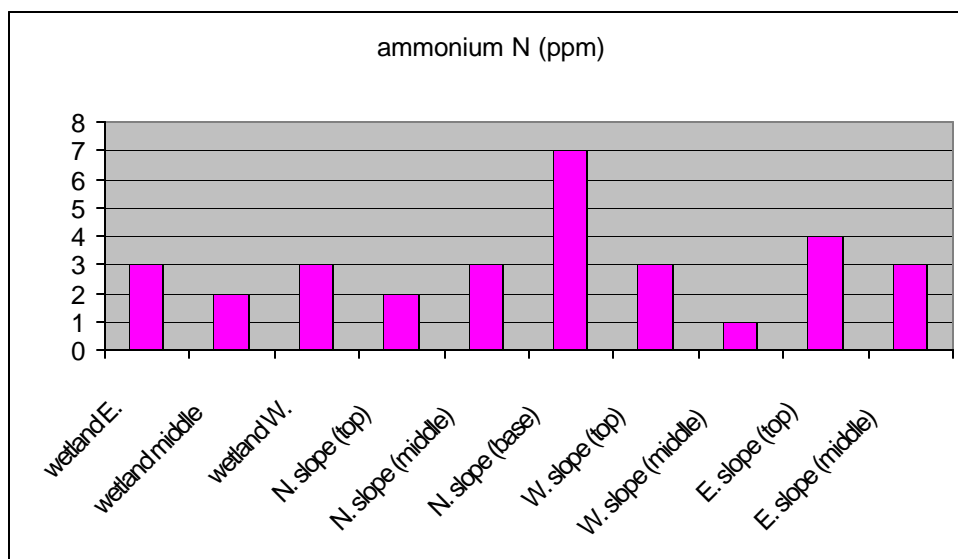
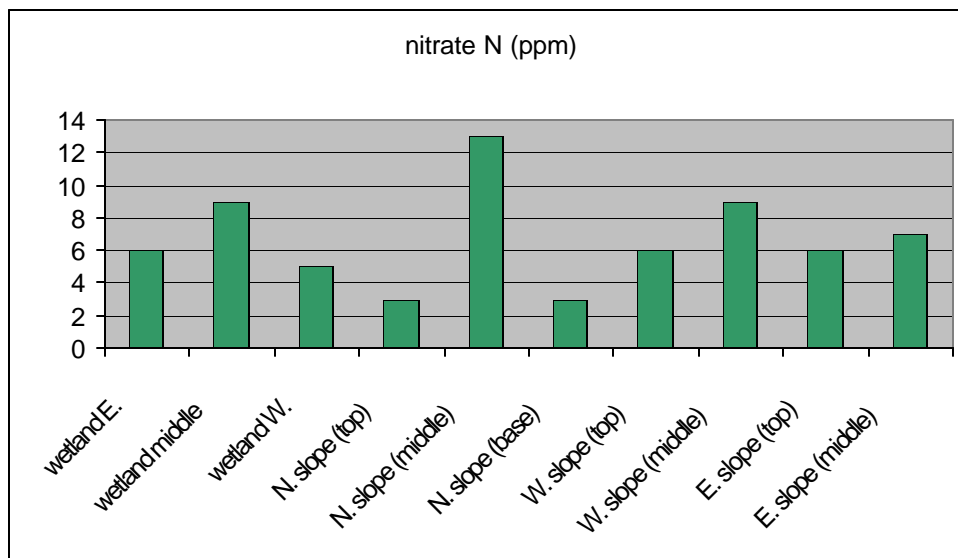
Figure 1. Graphic representation of soil analysis results (factor assessed is given at the top of each graph)

The vegetation on-site did not exhibit nutrient deficiency symptoms, so we have no reason to believe that nutrient availability will be a limiting factor at the site. For the most part, the soil results bolstered this conclusion, and most nutrient analyses revealed normal to high values. Interestingly, the soil from the base of the north slope displayed relatively high ammonium levels compared to the rest of the site (Fig. 1). The high nitrogen levels in this area could perhaps be attributed to the fact that all of the run-off from the above ravine, potentially being laden with fertilizers from the surrounding residences, collects here and flows through the drain, affecting the soil as it passes through.

On the other hand, the relatively low results for organic matter in the wetland were quite surprising because it was expected that this area of the site would exhibit high values because decomposition is suppressed in the anoxic conditions of saturated soils found in wetland. Also, the mucky nature of the wetland suggested that it was high in organic matter.
