Leschi Natural Area

East Alder Street Entry

A Report for the Friends of Leschi Natural Area

A Class Project for EHUF 480

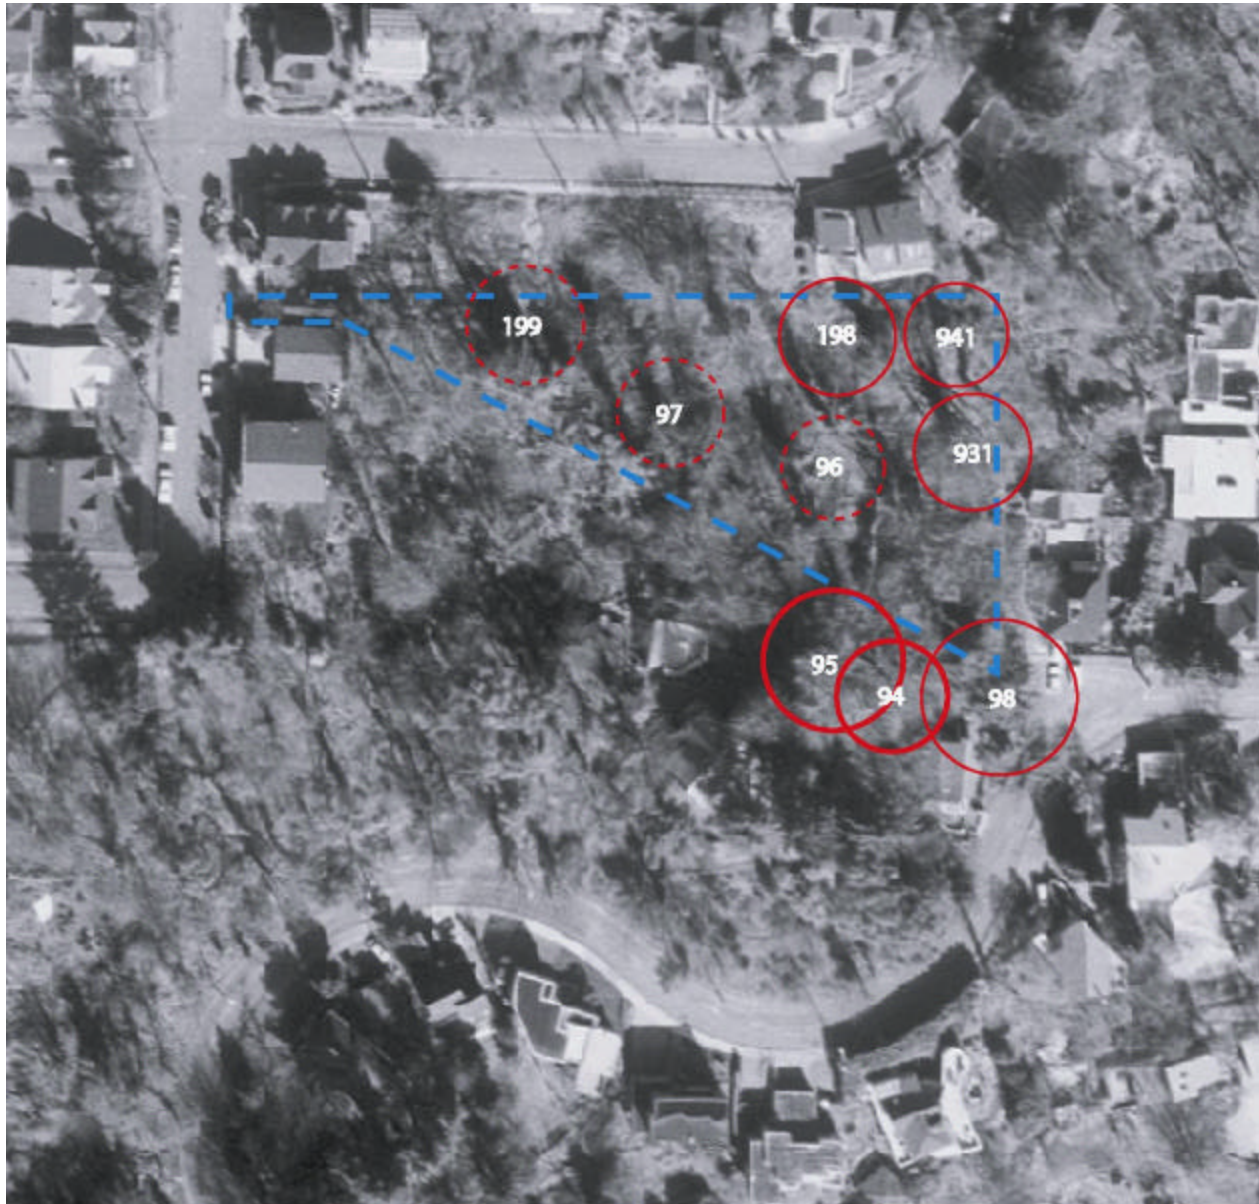
931 tree tag number

monitor

high hazard

At the southern entrance to the site an *Arbutus menziesii* (tag # 94) presents a hazard. This tree has a diameter of 28 inches a breast height and is in poor condition

for the size of the tree, only about 12 feet in diameter, and leans to the northeast about 20 degrees from the vertical. Ivy has begun to climb up the base of the trunk to a height of about 10 feet from ground level. A residential house, parking area, the street and power lines are in the target area. There is decay on the tension side. Removal of this tree was recommended in the report. The tree is located on private property and the owner was notified of the hazardous condition.

An *Acer macrophyllum* (tag # 95) was also documented to be in poor condition in the 2002 report. This tree is located on the same private property as tree number 94. Tree number 95 has a diameter of 31 inches at breast height. This *Acer* has some of the street in its target area and the SPR report recommended that this tree be pruned back or thinned to reduce risk. The trunk of this tree is also covered in ivy to a height of about 10 feet above ground level. The owner of the property was notified of these findings and recommendations.

Another *Acer macrophyllum* (tag # 98) is located near the E. Alder entrance to the site. This tree has five codominant stems each measuring between 16 and 18 inches in diameter at breast height. This tree appears to be in good condition and appears to have been pruned and cleared of ivy by SPR since the 2002 report. However, this tree is located on a steep slope and the species is prone to failure. The large number of codominant stems increases this risk. The target for this tree is the street, parking area, two residential houses and power lines. This tree is in excellent health and its large size offers many benefits. The hazard level of this tree should be monitored so that its health can be protected and the tree can be preserved.

Tree number 96 is another *Acer macrophyllum*. This tag number actually refers to a close growing group of multi-trunked trees with diameters ranging from 10 to 18 inches at breast height. SPR has pruned some large branches to reduce the hazard potential of this tree. They currently have this tree listed on monitor status to watch for future hazard potential. There is some ivy growth on the trunks of this tree.

A large *Acer macrophyllum* (tag # 97) is located upslope. This tree has three codominant trunks with diameters ranging from 18 to 22 inches at breast height. The union between the trunks is a potential point of failure. There is currently no target for this tree but with the addition of the pathway the hazard will need to be reassessed.

Another *Acer macrophyllum* (tag # 198) is located on the northern edge of the site. This tree has a diameter of 41 inches at breast height. SPR has pruned this tree to reduce the hazard to adjacent homes. There is a “large wound at the base with extensive decay”¹² that will require monitoring into the future.

Towards the northeast corner of the site another *Acer macrophyllum* (tag # 199) presents a potential hazard. The trunk has a 45-inch diameter at breast height. This tree has a very low branching angle between two codominant stems. The tree is around 50 feet tall and may target the house to the east. This tree should also be monitored closely as pedestrian traffic increases through the site.

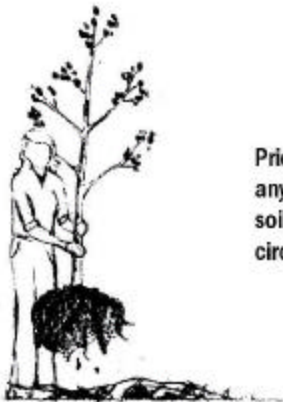
Plants that arrive balled in burlap should be planted as soon as possible. Store plants in the shade and keep the rootball moist.

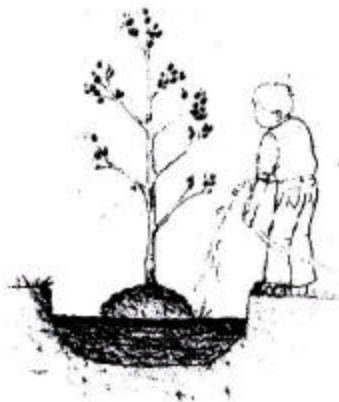
Prior to planting, the rootball of the tree should be completely unwrapped and any burlap, twine or wire should be discarded. Remove as much of the clay soil as possible from the roots of the plant. Inspect the roots for any kinked, circling or girdling roots and remove them with clean pruners.

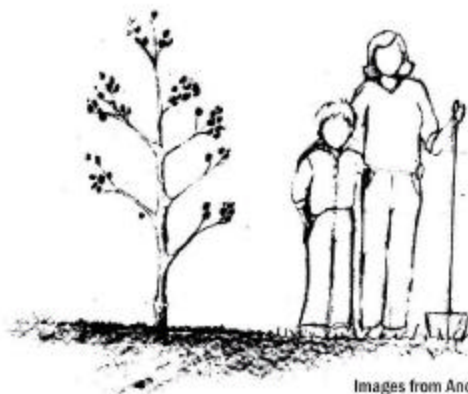
Inspect the size of the exposed rootball and dig a hole that is at least twice as wide as the roots of the plant. The hole should be no deeper than the roots of the plant and should have a small mound at the center of the bottom of the hole to spread the roots over. Rough up the edges of the planting hole to remove any soil glazing from the digging process. Place the plant into the hole and gently arrange the roots so that they spread away from the center of the hole in a radial pattern ensuring that no roots are kinked or looped. Backfill the hole with native soil and water deeply to settle the soil around the roots.

Construct a "soil moat" around the top of the hole to keep water in the area of the roots. Cover the area with a thick layer of mulch. Taper the thickness of the mulch down around the plant to keep it away from the trunk. Water regularly and deeply until the plant becomes established and then gradually decrease the amount of irrigation.

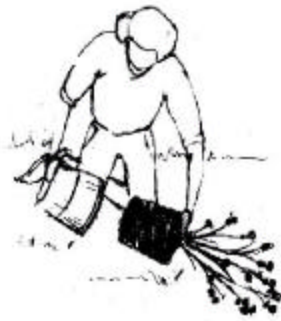
Plants that arrive balled in containers can be stored in the shade. They should be watered regularly and checked at least daily to be sure that they do not dry out.

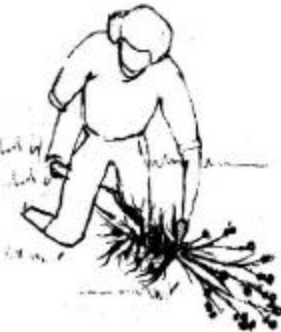
Prior to planting, the rootball of the plant should be removed from the container. Remove as much of the container media as possible from the roots of the plant. Inspect the roots for any kinked, circling or girdling roots and remove them with clean pruners.

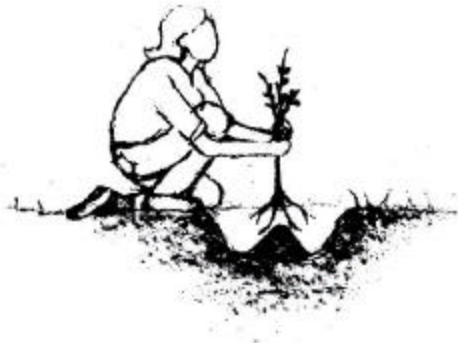
Inspect the size of the exposed rootball and dig a hole that is at least twice as wide as the roots of the plant. The hole should be no deeper than the roots of the plant and should have a small mound at the center of the bottom of the hole to spread the roots over. Rough up the edges of the planting hole to remove any soil glazing from the digging process. Place the plant into the hole and gently arrange the roots so that they spread away from the center of the hole in a radial pattern ensuring that no roots are kinked or looped. Backfill the hole with native soil and water deeply to settle the soil around the roots.

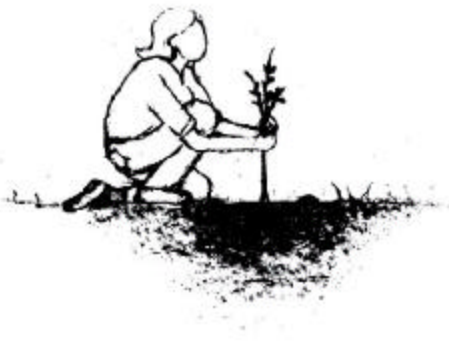
Construct a "soil moat" around the top of the hole to keep water in the area of the roots. Cover the area with a thick layer of mulch. Taper the thickness of the mulch down around the plant to keep it away from the base of the plant. Water regularly and deeply until the plant becomes established and then gradually decrease the amount of irrigation.
