Mercer Madison Woods

Winter 2004

EHUF 480

abstract

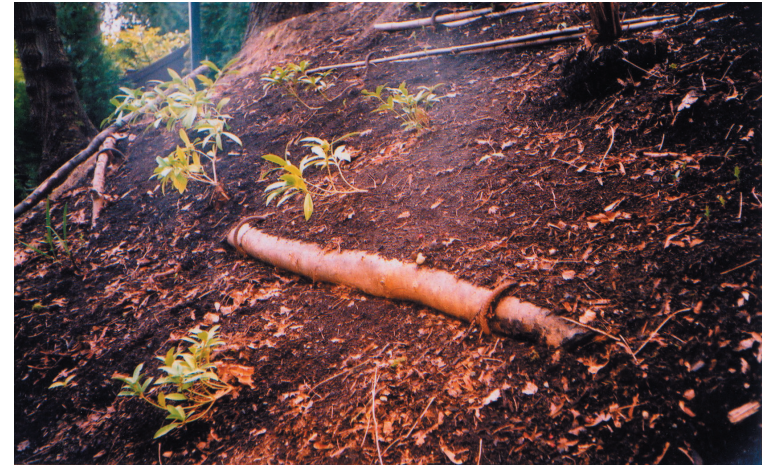
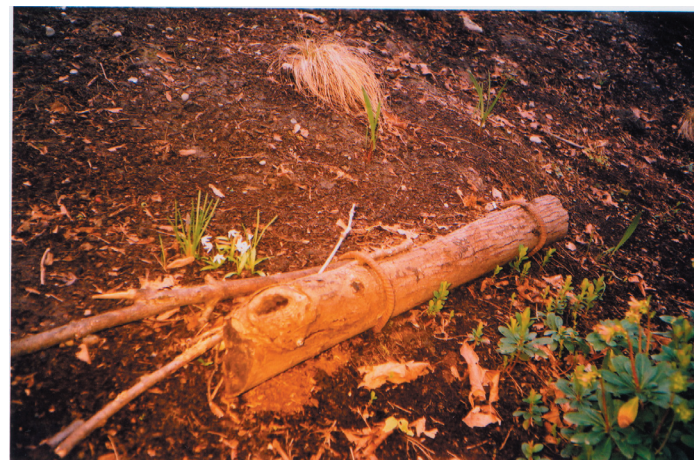
Examples of stabilization technique using branches and rebar

What we are recommending is staking some of the larger pruned branches (3-5 in. diameter, 1 ½-2 feet long) into the sides of the steeper slopes using J-shaped pieces of rebar. This method is simple enough for any skill level to perform, uses on-site resources, and only requires several long pieces of pre-bent rebar. Though there is little documentation supporting this technique, it has proven successful in some residential landscapes, such as in the above photo.

In the Mercer Madison Woods, the only slopes steep enough to require erosion control are along the upper edge near Madison Street. The branches should be staked in 5-foot intervals up the slope, and spaced about 5 feet apart across the slope. The branches should also be staggered to increase erosion control effectiveness and to give it a more natural, random appearance. The key to this technique is to choose branches that fit snugly into the crook of the “J” of the rebar. If it is not tight, the branch could come loose, reducing its effectiveness and creating a possible safety hazard. The pieces of rebar will also have to be checked periodically and removed after the branch pieces have decayed.

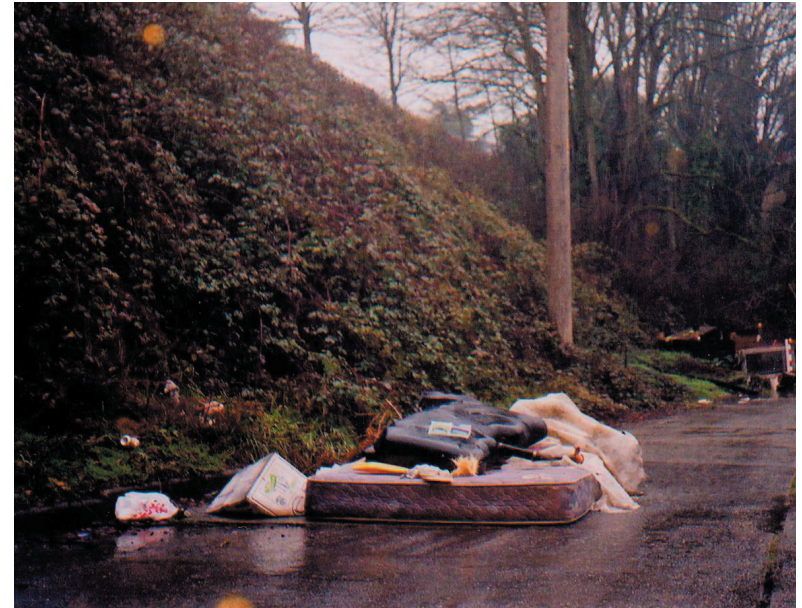
Garbage dumping along Mercer Street.

It will be necessary to remove trash and brush piles before planting the site. Most of the trash can easily be picked up and bagged. Gloves should be worn as there is much broken glass on site. There are also several tires that have been dumped on the property. These will have to be removed and disposed of properly. There
