# Heron Glen Wetland Buffer Enhancement Project

## Progress Report

August 10, 2004 (resent October 19, 2004)

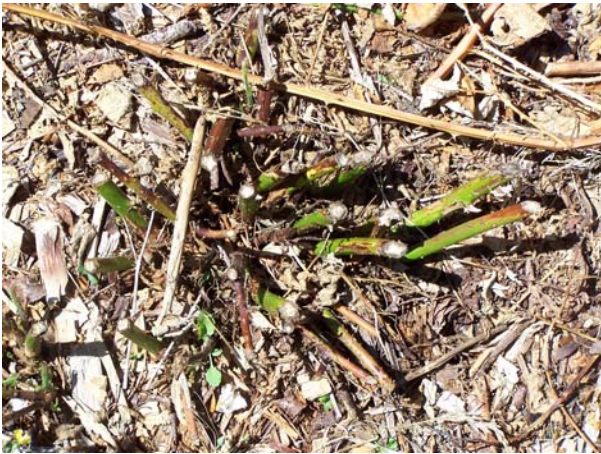
**Photo 1.** Blackberry canes cut and painted with a glyphosate solution.

Himalayan blackberry is the most troubling plant on-site. Last year, the majority of blackberry control was done by pulling of plants. This resulted in a large amount of re-growth from the roots, and was disruptive to the soil structure. Blackberry plants are currently being pulled only if the plant is very small; all other canes are cut near the ground and daubed with glyphosate. Glyphosate-treated canes have shown little to no re-growth (See Attachment 1, Photo 1). In 2004 the eastern portion of the site has been cleared of blackberry, we are currently working on the western portion. If the glyphosate treatment is as effective as we anticipate, there should be a significant reduction in blackberries next year.

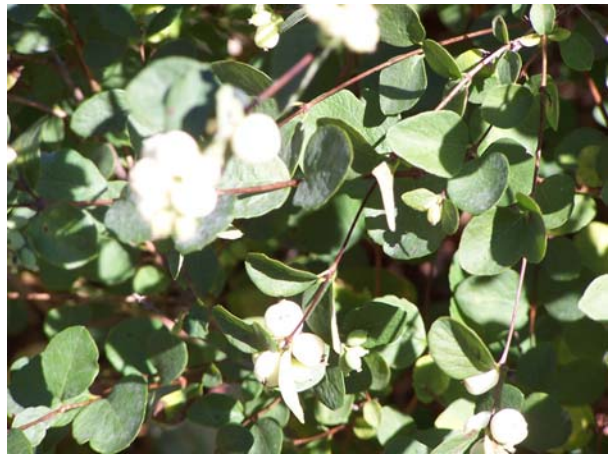
**Photo 3.** Snowberry fruit

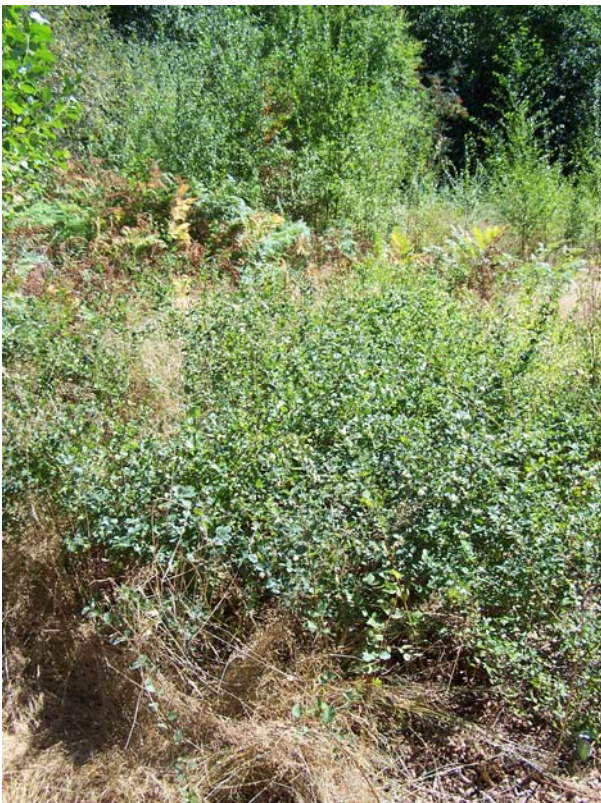
Additionally, there are a number of volunteer shrub species starting to appear. We have seen several snowberry (*Symphoricarpos alba*), and rose (*Rosa nutkana*). There are also a few native honeysuckle (*Lonicara involucrata*.) and elderberry (*Sambucus* sp.).

**Photo 2.** Volunteer Snowberry (*Symphoricarpos alba*)
